The Crash of Flight 201/8

by Linda Burdette, Feature Article Editor

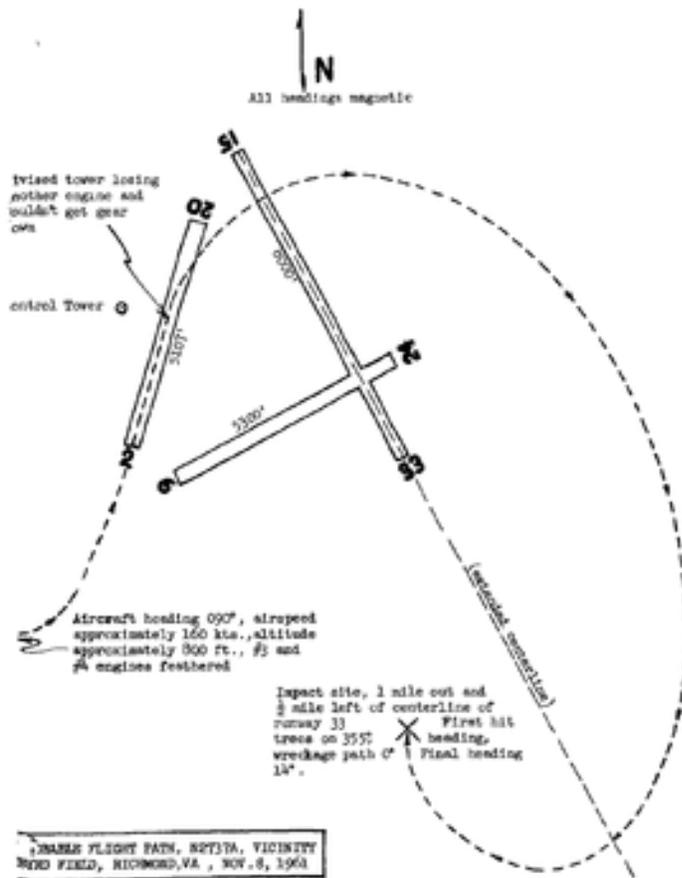
Diagram of Flight 201/8 approach to Byrd Airport

Lining up for landing, they realized that the hydraulic power to the landing gear was supplied by the two right side engines and the nose gear would not lock into place. They decided to do a go-around to gain time to get the landing gear deployed and locked. They apparently planned to land on Runway 33 on the second pass. However, on the turn for final approach, Flight Engineer Poythress reported losing power on engine 1 due to high engine temperature caused by the surge of power at low speed. Seconds before crash, the pilot radioed "I can't get my gear down and I'm losing another engine."

Richmond tower told the crew to use runway 33, a northwest lane and 8,000 feet long, but Captain Conway later reported that since they were approaching from west they couldn't use it. So as they approached the airport, First Officer Greenlee, without warning to the Captain, turned to attempt a landing on runway 02.

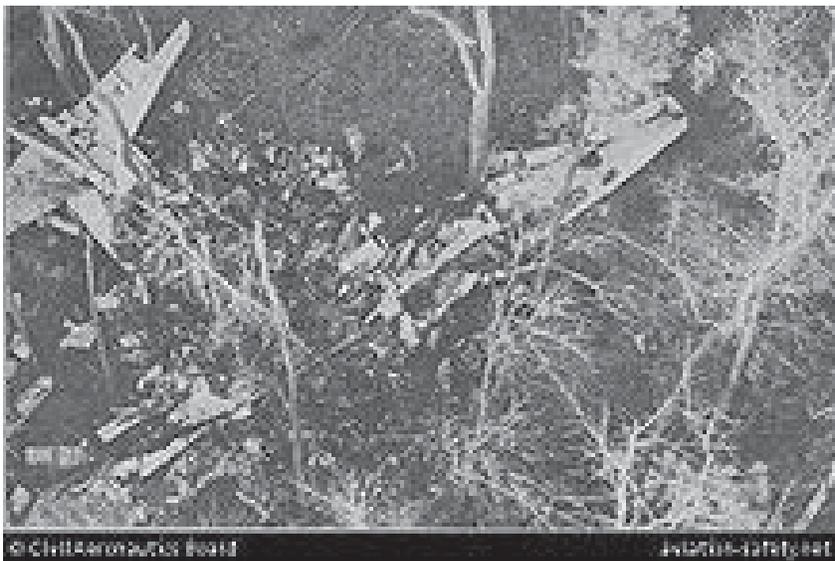
Photo of crash site

The pilots knew they were in trouble with only one engine. Conway saw the trees coming and Greenlee called "get on it with me, Ronnie" as the plane started to settle. Both grabbed the controls and put the airplane in a nose-high attitude to lessen the impact, feeling the jolt when they hit the trees. The airplane pancaked into a marsh two miles short of the runway, but Conway said the impact didn't seem particularly bad, although he was knocked forward, hitting the control wheel. According to witnesses, the airplane had regained about 700 feet of altitude when it crashed and there were reports of as many as three explosions immediately after the crash.

The CAB investigation revealed that none of the passengers had been advised of emergency procedures or emergency exits and went on to note the location of the bodies “indicated that many of the passengers had left their seats after impact and had attempted to evacuate the aircraft. The largest group of bodies was found near the main cabin entrance door, which either had been jammed by the ground impact or by trees and debris which were piled up against the fuselage.” Flight Engineer Trainee Clark and Stewardess Johns were found in the cabin with the passengers, but “[t]here was no evidence to indicate that attempts had been made to use any of the emergency over-the-wing window exits. The charred remains of what appeared to be the emergency escape slide retaining bar was found lying across the bottom of the main cabin door opening.”
